Dryer Update

Vesuvius McDanel-Beaver Falls installs a dryer solution from Ceramic Services, Inc.

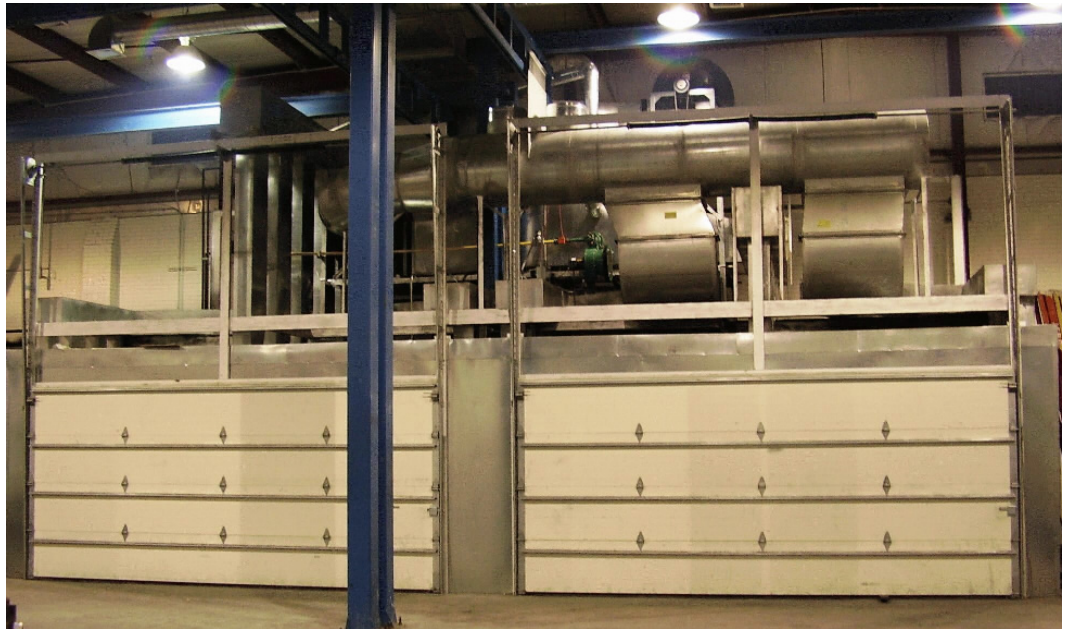
The Ceramic Services Drying System pictured below featuring:

- Redesigned and Rebuilt low turbulence duct flow system
- Two circulating air blowers complete with 480V three phase motors
- Two control cabinets which include the motor starter for the fans as well as controls for relative humidity, temperature, and static pressure.
- Two burners, blowers and flame monitors.
- Two heat exchangers
- Two motor controlled dampers for each side controlling humidity and static pressure.
- Two water misting nozzles and shut off solenoids.

The Solution: A complete rebuild of the current dryer with:

- Positive pressure drying chamber
- Non turbulent air flow
- Relative humidity control
- Dual Heat Exchangers
- 200 Degree F. max. heat
- Control system for each unit
- Dual sided control for Air, Temperature, and Humidity
- Dual circulating air blowers
- Dual control cabinets

The Result: A complete functional drying system with two complete drying sections that are independently controlled. The production backup has now been eliminated. The drying efficiency of the company's' advanced ceramics has been greatly improved.
