# “Kilnman”

## Dryer Update

### Artistry in Mosaics-Ft. Pierce, FL. installs a dryer solution from Ceramic Services, Inc.

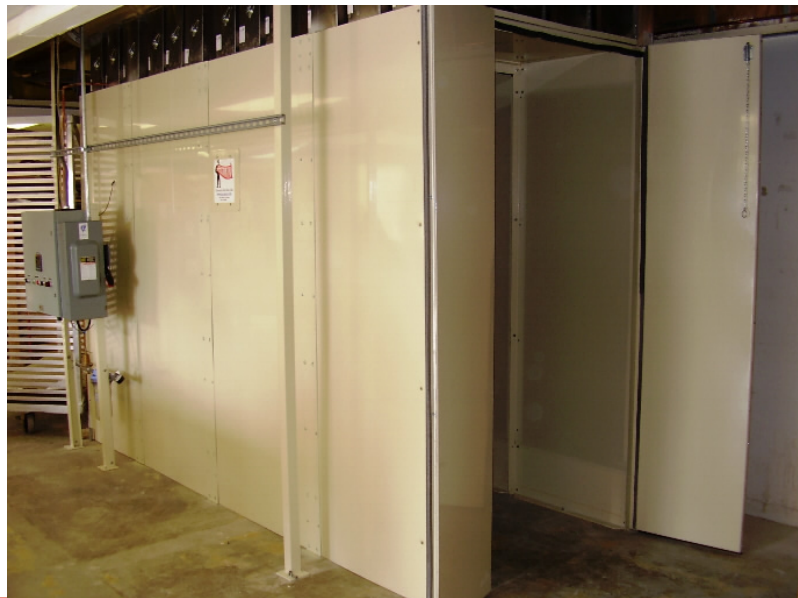
#### The Ceramic Services Drying System pictured below featuring:

- An insulated drying enclosure with two doors.
- Two carts large enough to hold the molding trays for a days production of tile.
- One pre-wired control cabinet, which includes the motor starter for the fan and control for relative humidity, temperature, and static pressure.
- One 208V, three phase, 18 KW electric heater with solid state power controls.
- Two air control valves with respective control valve motors.
- Sensors for temperature, and relative humidity, wired into the control cabinet.
- One water misting nozzle and shut off solenoid.

**The Solution:** A Ceramic Services drying system designed to dry the tile on the molding sheets without warping or cracking by using large volumes of low velocity air with controlled temperature and humidity. This drying system is designed for very even, high volume, and low turbulence air flow with the drying chamber under positive pressure.
